# Manhole Inspection Summary

Manhole # S37AA1008MH

Insp Date: **1/3/07 9:21 AM**

**Location** Address: **607 35TH ST**

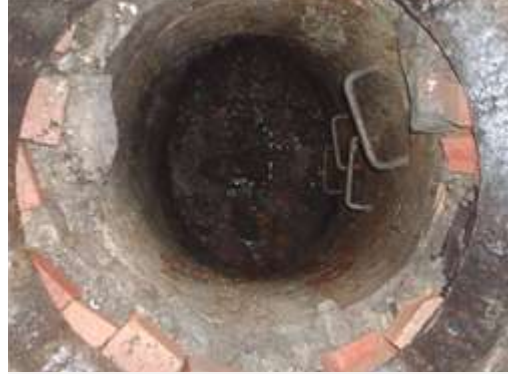
Top View

☐ Parged ☒ **Debris** (not Condition related)

Condition: ☐ Sound ☐ Cracked ☐ Root Intrusion ☐ Deteriorated ☐ Leaks ☒ **Debris**

**Surcharge** ☒ **Evidence Of Surcharge** Depth: **1** (ft.) ☐ Active Surcharge Present

Evidence of surcharge - Bench debris.  
Channel debris.

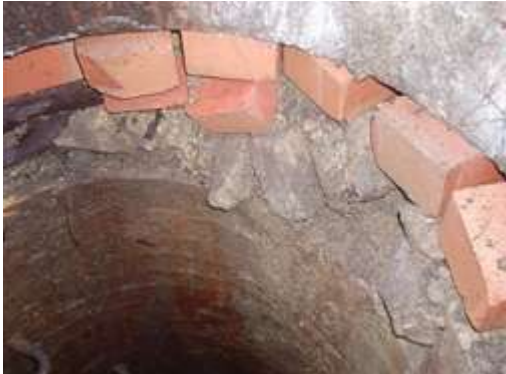
Defect

☒ **Leaks**

Condition: ☐ Sound ☐ Cracked ☐ Root Intrusion ☒ **Loose Brick** ☒ **Deteriorated**

Frame leaks. Frame offset. Adjustment  
deterioration, loose brick and infiltration.

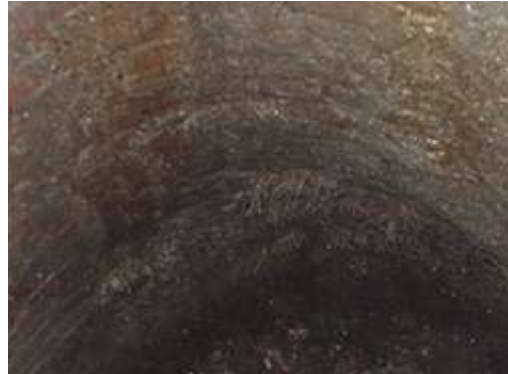
Defect

Infiltration: ☐ None ☒ **Joint** ☐ Cracks ☐ Mortar ☐ Roots ☒ **Wall**

Condition: ☐ Sound ☐ Cracked ☒ **Root Intrusion** ☐ Loose Brick ☐ Deteriorated

Infiltration: ☐ None ☐ Joint ☐ Cracks ☐ Mortar ☒ **Roots** ☒ **Wall**

Adjustment infiltration. Corbel and Barrel  
root intrusion and infiltration.

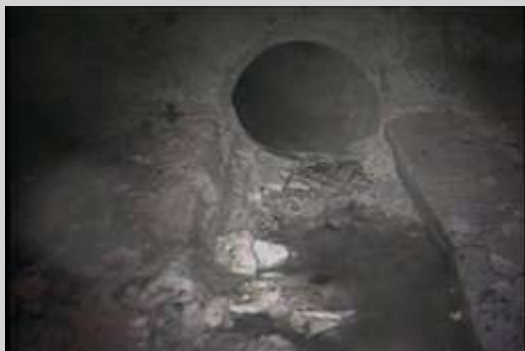
### 6 in. Circular Gravity Sewer Pipe In @ 6 O'Clock

Deposits: ☒ **None** ☐ Mud ☐ Sludge ☐ Debris ☐ Grease

Infiltration: **None** Pipe Seal Cond: **Unknown**
